# Enhancing photovoltaic module sustainability: Defect analysis on partially repaired modules from Spanish PV plants

M.B. Nieto-Morone<sup>a,b,\*</sup>, F.G. Rosillo<sup>a</sup>, M.A. Muñoz-García<sup>b</sup>, M.C. Alonso-García<sup>a</sup>

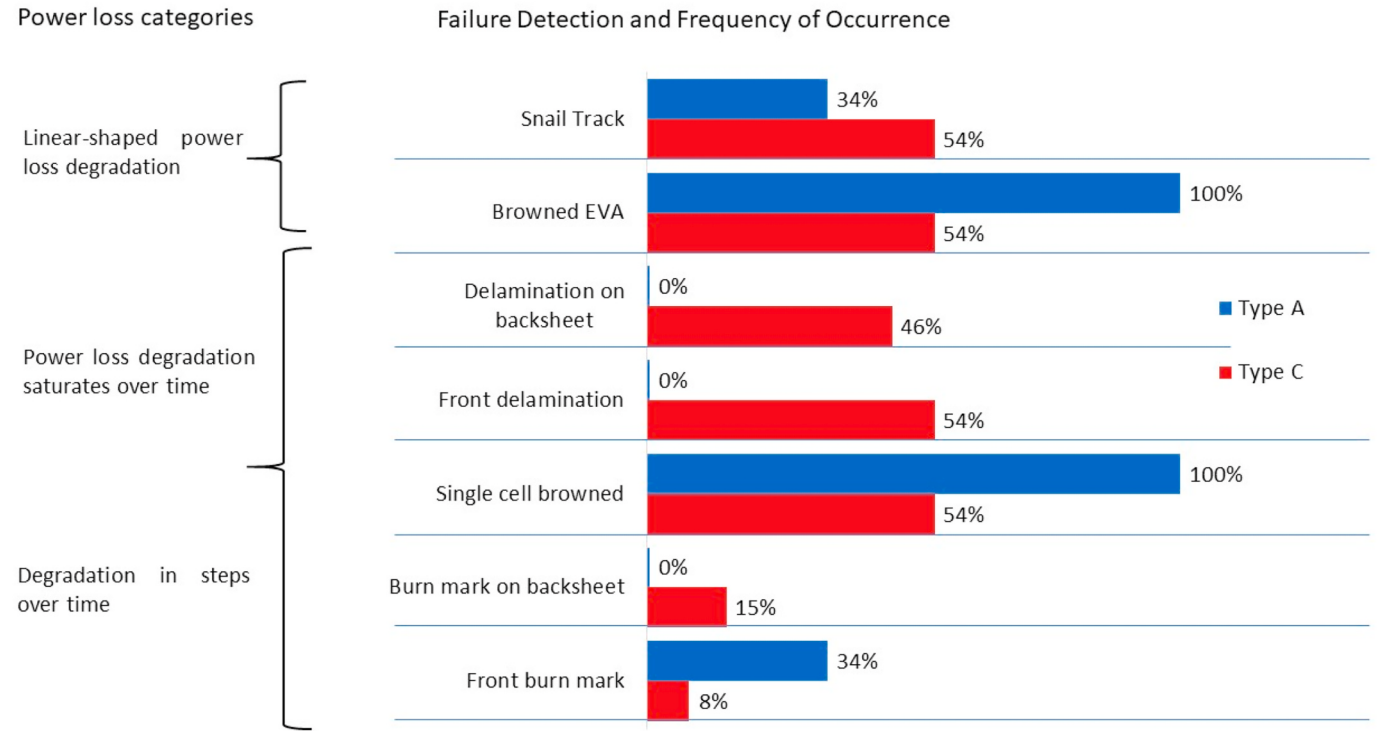
Fig. 2 compares the results of module types A and C due to the similarity of their technologies and results. Type B, which is not included in Fig. 2, only exhibited an 80 % occurrence of exposed welds on the backsheet and no other visible anomalies. This irregularity results from the repair process and not a module failure. The completion of the repair process in this set of modules remains outstanding. The exposed welds are also found in types A and C, with percentages of 83% and 92%, respectively.

The results show that the modules exhibit optical degradation due to delamination and discolouration of the encapsulation. Delamination at the cell interface can be classified into two main types: front-side and backside delamination. Backside delamination usually appears as surface bubbles, which could cause the formation of hotspots, leading to a decrease in the system's energy output. In contrast, front-side delamination displays a distinct grey appearance when it arises at the cell interface (Meena et al., 2020).

**Fig. 2.** Failures detected after visual inspection test relationship with power loss categories according to (Kontges et al., 2018) in type A and C m-Si modules.

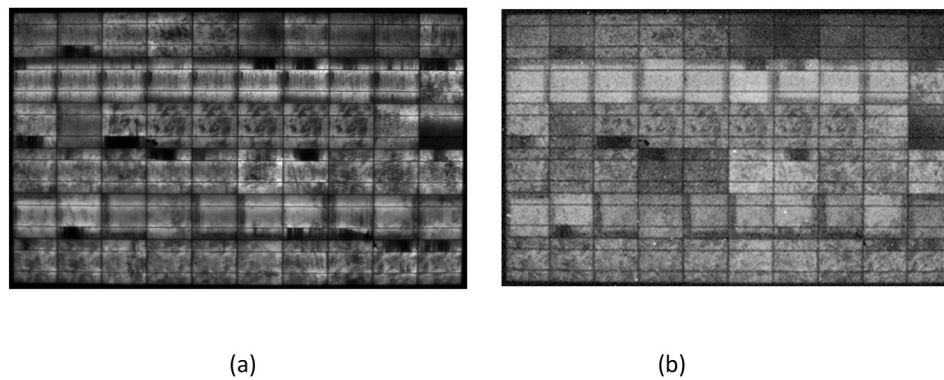
impact of moisture penetration through microcracks and its degradation effects elsewhere. Our findings align with other reports, as evidenced by (Kajari-Schröder et al., 2012). It can be seen in Fig. 6 an example of this type of failure, the moisture-induced degradation, MID, explained in section 3.1.

**Fig. 6.** Electroluminescence images of m-Si taken under (a) Isc and (b) 10 % of Isc forward bias conditions exhibiting MID.

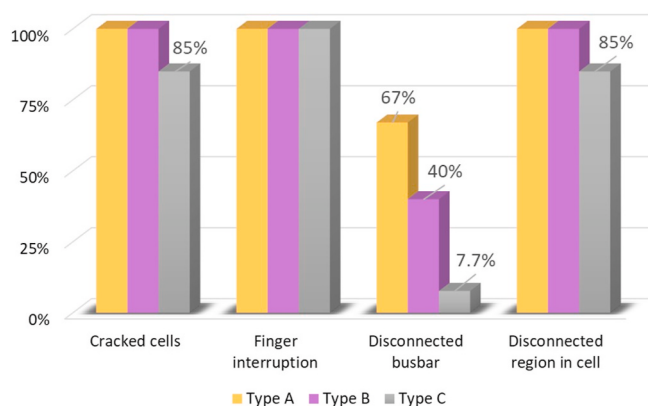
Other failures, such as finger interruptions, cell cracks and short-circuited busbars, were also detected using electroluminescence imaging because of the reduced luminescence from these defective areas. Fig. 7 presents the results we obtained after analysing the modules of the three types of modules.

**Fig. 7.** Percentage of modules affected by the defects revealed in the electroluminescence images. Bars without labels have a failure occurrence rate of 100 %.

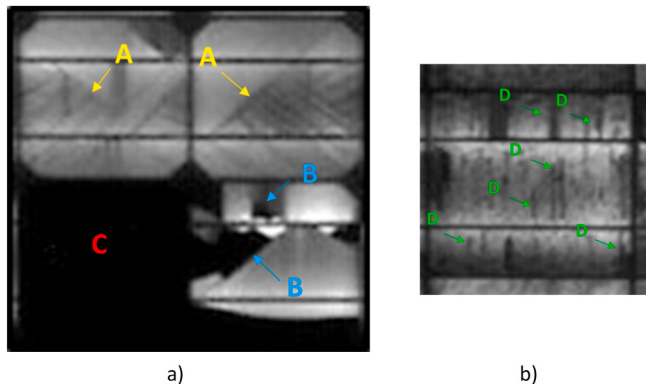
Some cracks do not interrupt the current flow, while others electrically insulate the region in the cell. The non-disruptive cracks have been denoted as "A", while the electrically insulated areas are indicated as "B" in Fig. 8. Although both images display cracks labelled as "A," they

exhibit different patterns. In photo a), the crack pattern is branched, while in photo b), it may be attributable to impacts on the module. The cell marked as "C" is entirely disconnected from the circuit and is bypassed because of a reparation. The "D" faults are broken fingers, which are similar to other cases documented in the literature and originate during soldering (Spertino et al., 2015).

**Fig. 8.** Different failures detected with EL. a) Dendritic or branched cracks denoted by "A". Deep cracks disconnecting a region in the cell denoted by "B". Disconnected cell denoted by "C". b) Broken fingers denoted by "D".

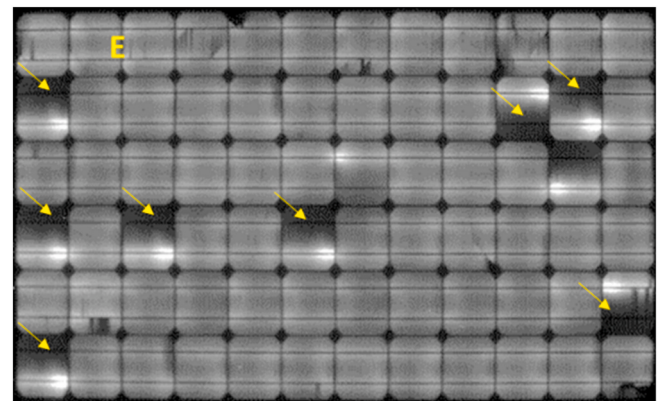
Inadequate soldering, thermomechanical stresses, or the presence of hot spots can damage or deteriorate the connecting ribbons between the solar cells or the busbars, resulting in a mismatch in the PV module's electrical parameters. Fig. 9 shows an EL image of a module exhibiting several examples of this failure.

**Fig. 9.** Several disconnected busbars in a module type C. Note that as one of the two busbars in each defective zone is active, then the current flows.

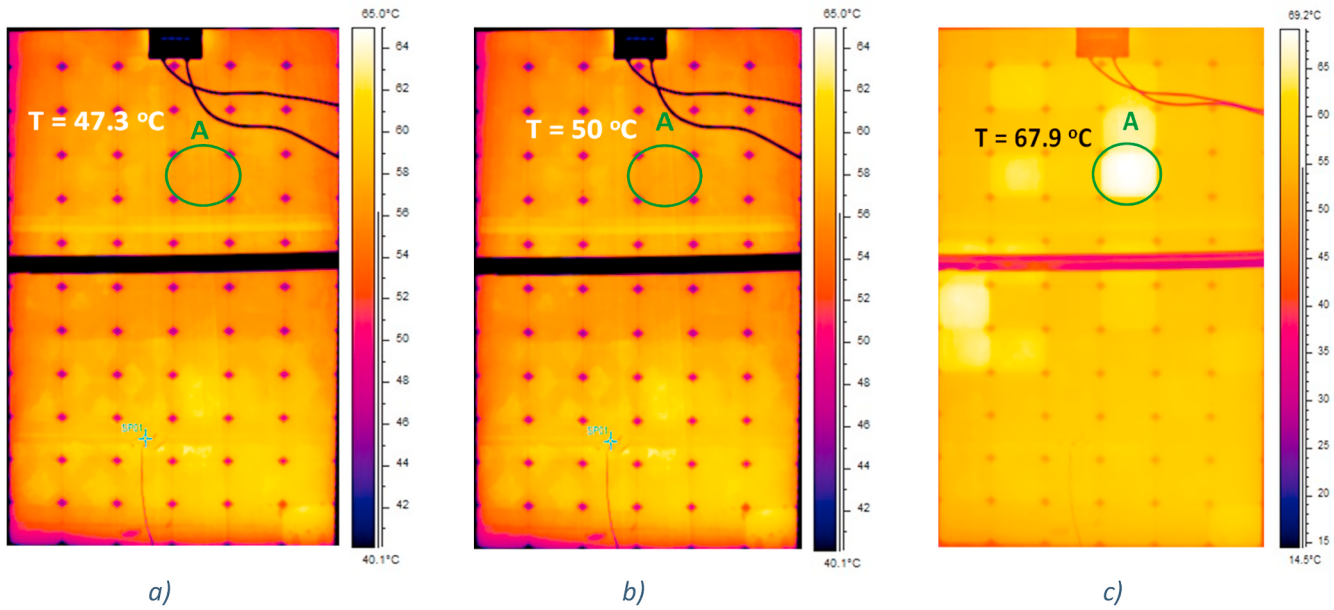
Fig. 10 presents the most significant temperature differences observed between operating near maximum point and short-circuit operating conditions were around  $17^\circ\text{C}$  in the marked area "A".

Under this categorisation, thermographic images revealed "strong hot spots" in a percentage of 4.35 % of the examined modules operating near their maximum power point, whilst 2.3 % presented strong hot spots during short-circuit operating conditions and 74 % displayed "light hot spots". In this last group, we found that 47 % had featured high temperatures in the junction boxes, attributable to the diode's activation and further energy dissipation. Furthermore, all photovoltaic modules in their operating point condition exhibited a temperature pattern that closely resembles the one described in (Ulrike et al., 2018), where the solar cells situated near the junction boxes typically operate at temperatures  $3^\circ\text{C}$  higher than those located in other parts of the cell matrix.

**Fig. 10.** Infrared thermographic images of a PV module operating in a) open circuit, b) near maximum power point, c) short circuit. The encircled region marked “A” corresponds to the maximum temperature area. Test conditions: Irradiance 923 W/m<sup>2</sup>, T<sub>r</sub> = 20 °C.

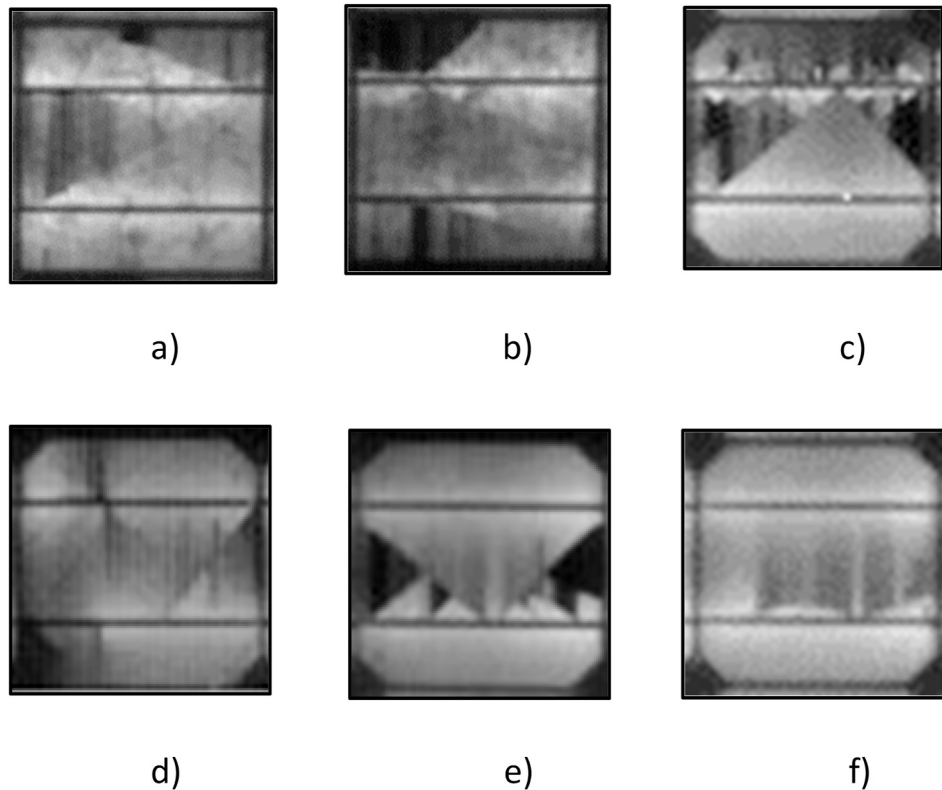
electroluminescence and classified them as multidirectional, diagonal, parallel, and perpendicular to busbars. These papers indicate that while the cracks may not cause cell disconnection, they can develop resistance to current flow when operated continuously. Additionally, the papers have determined that cracks parallel to the busbars are critical because they decrease the current flow (Dhimish et al., 2017; Kajari-Schröder et al., 2012). As shown in Figs. 8 and 11, our analysis revealed that the cracks in our study mainly allow current conduction, with the most

common direction of crack occurrence being diagonal (40.21 %), while cracks perpendicular or parallel to the busbars accounted for only 22.7 %.

**Fig. 11.** a), b), c), d), e) Diagonal cell cracks. a), c), e), f) Parallel and perpendicular. d), e) Multidirectional cell cracks.

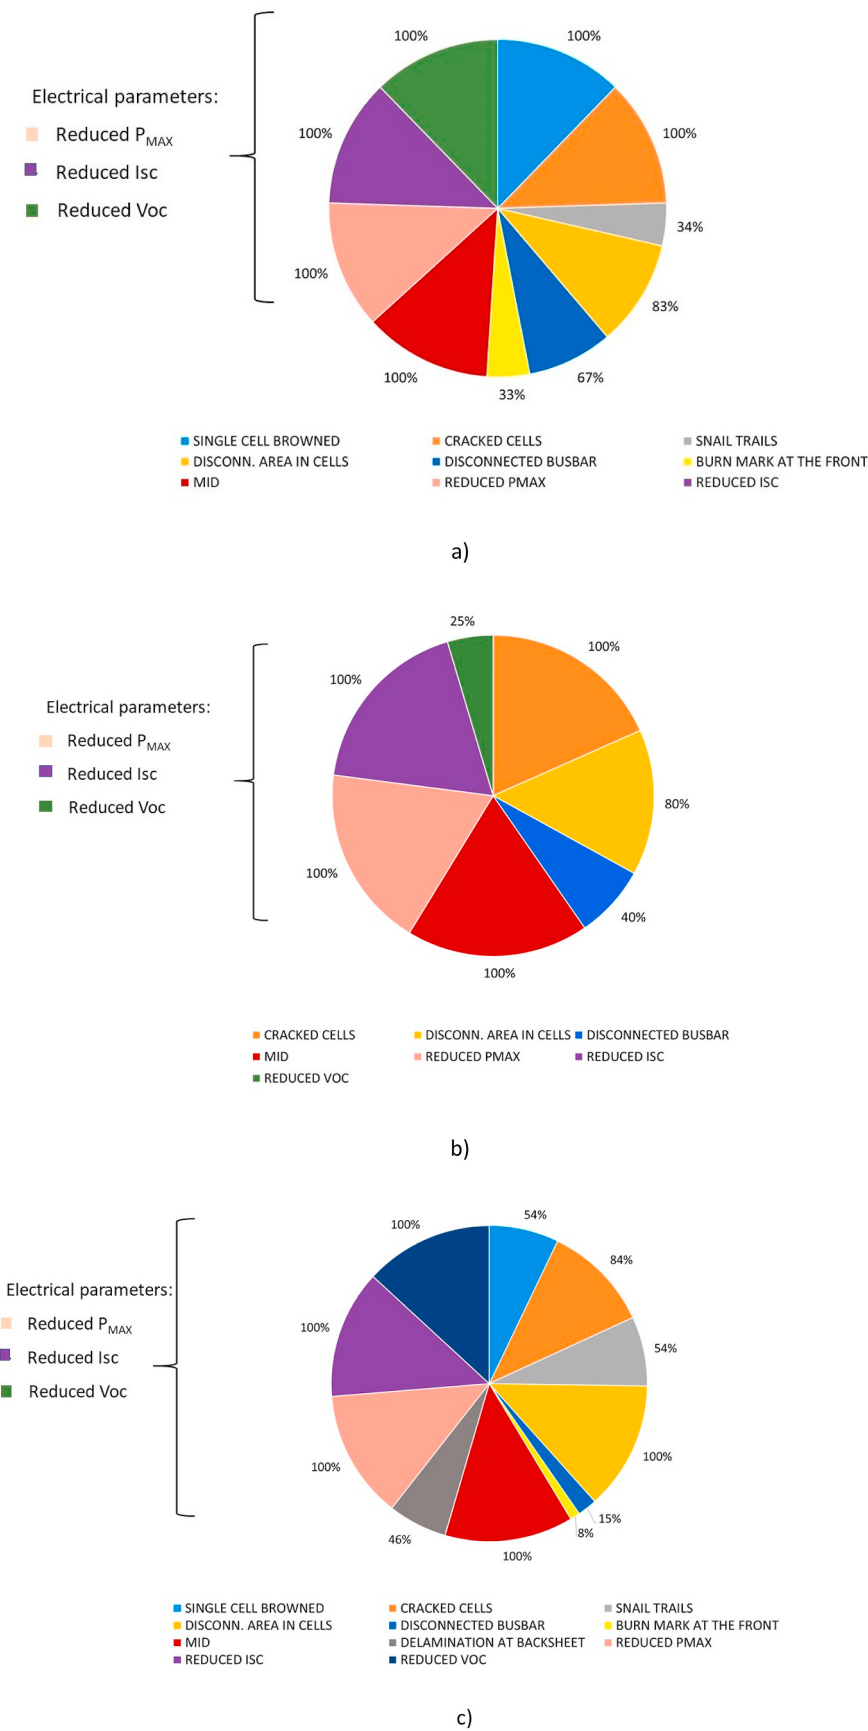
Fig. 14. a) Frequency of failures in type A modules. b) Frequency of failures in type B modules. c) Frequency of failures in type C modules.

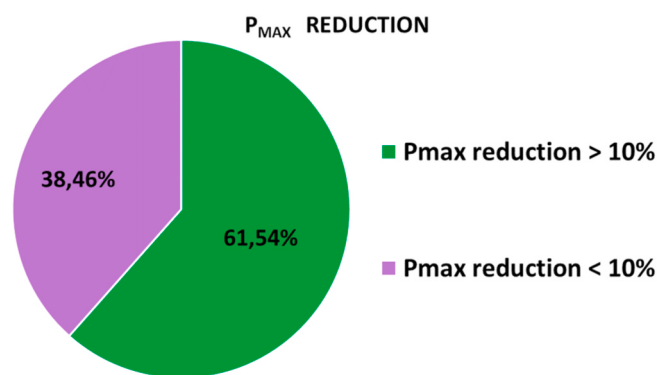
Regarding the reduction in power, 80 % of polycrystalline modules of type B have experienced a peak power reduction of less than 10 %, based on our findings. This is also applicable to monocrystalline modules of type A. In contrast, type C modules demonstrated a distinct outcome, as depicted in Fig. 15. This decline is attributed to their higher susceptibility to degradation due to Moisture-induced degradation (MID), as evidenced in the EL images (refer to Appendix A for the complete set of images).

Fig. 15. Maximum Power reduction found on modules type C.

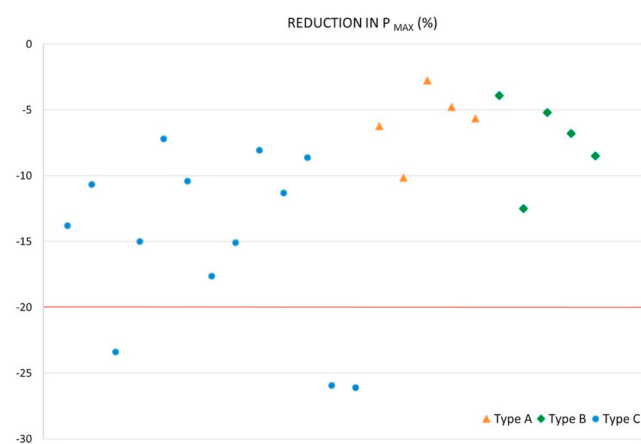
Analysing the power reduction in the complete set of modules, our results show that despite the presence of defects, around 87 % of these modules exhibit a power reduction of less than 20 %, as depicted in Fig. 16.

Fig. 16. Analysis of Maximum power reduction of the 23 partially repaired modules.
