# Repairing ribbon bus bar interruptions in photovoltaic modules using non-intrusive interruption location

Ribbon bus bar interruptions in photovoltaic modules represent approximately a 10 % of photovoltaic module failures. The purpose of the present work is to repair this failures using the simplest, fastest and cheapest techniques. Twin and single intercell interruptions are defined. The first one, twin intercell interruptions, cut off electrical current flow between two cells while the second one permits current flow between cells through just one ribbon bus bar at the cost of module efficiency reduction. We propose non-intrusive methods to find precise location of single and twin intercell interruptions. A simple technique for intercell interruption repairing is described. Three modules were repaired, multiplying its power production in two cases by 4, when comparing with its non-repaired power production. The third module did not produce any electricity before repairing, and after being repaired produced a power similar to its nominal value. The proposal of repairing can be put into practice in modestly equipped factories and laboratories, without using expensive and time con

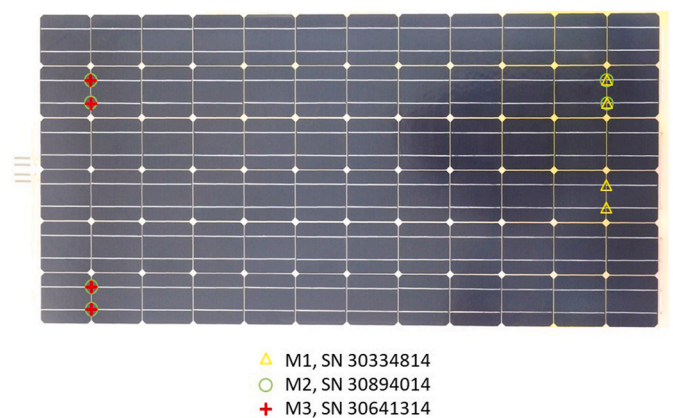
Fig. 1. Map of interruption detected in the three samples.

After an initial characterization described in section 2.2 we selected 3 modules out of more than twenty, whose main data are shown in Table 1. The table also includes the number of interrupted ribbon bus bar and some comments. Fig. 1 shows the specific interconnections that failed in the samples. A certain “preference” for some particular spots can be observed.

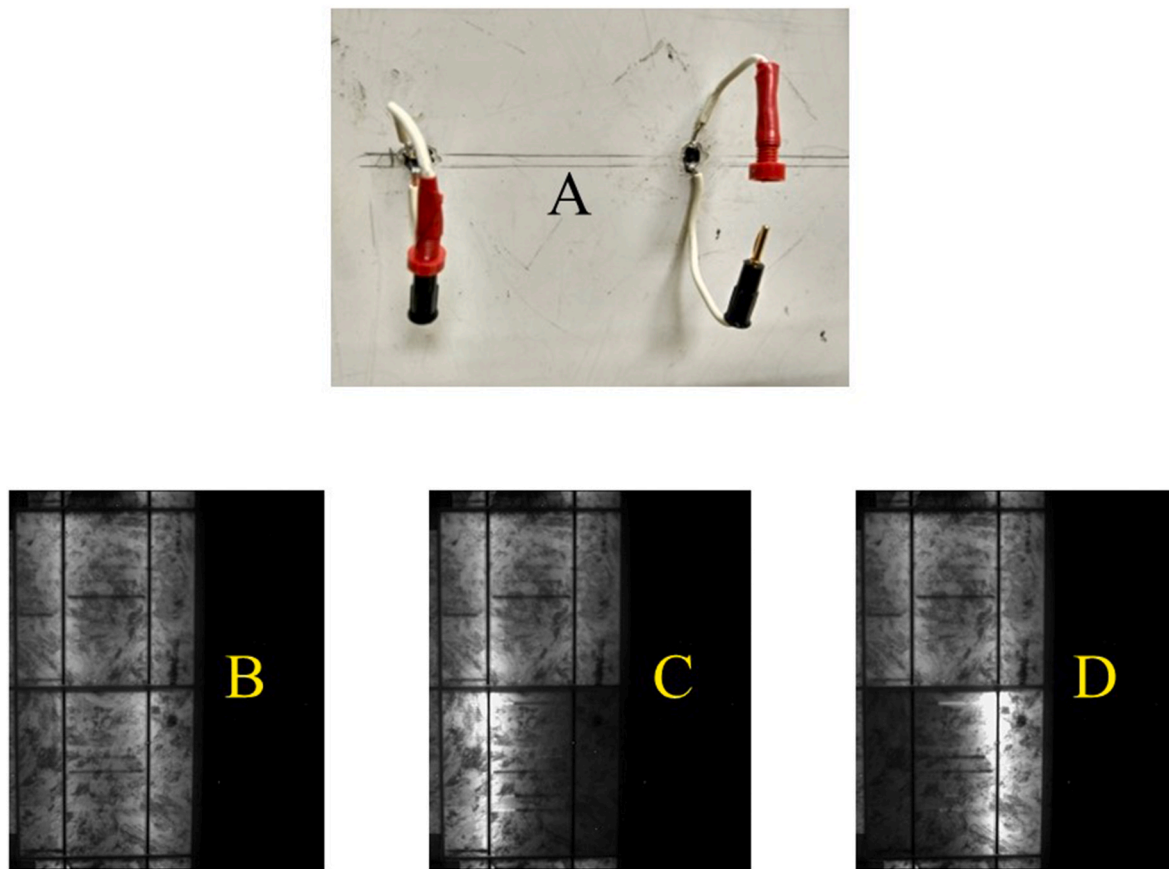
As can be seen in Fig. 8, partial ribbon bus bar interruptions are quite easy to identify in EL images. With reference to the repairing of this kind of failure, we consider that can be justified only when a total interruption of other series of cells force to repair the module. In our opinion, it is not justified to perform the repairing of this partial failure in a module that supply most of the power expected, due both to economic reasons and to avoid the risk of damaging de module if a failed repair occurs.

**Fig. 8.** Above, (A) intercell ribbon bus bar arrangement for connection and disconnection of ribbon bus bar. Below left, (B) electroluminescence with both ribbon bus bars connected. Below center, taking as reference the active face of the module (C) electroluminescence with right ribbon bus bar interrupted. Below right, (D) electroluminescence with left ribbon bus bar interrupted. Note that connected and disconnected ribbon are inverted in A.

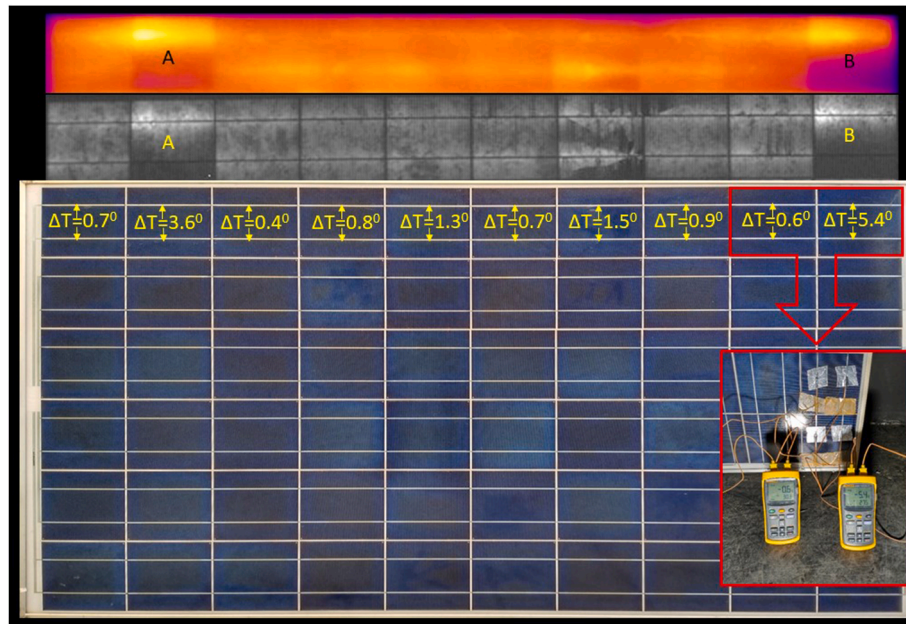
**Fig. 10.** Difference of temperature of ribbon bus bar for the upper series of cells of Module M2, when a current of 7 A is flowing. A thermography is shown above, an EL image in the center and the visible image of the whole module below. The red border inset image shows the measurement of two of the cells with thermocouple. The yellow inscriptions show  $\Delta T$  between the ribbons of each cell, to be compared with their electroluminescence and thermographic images at the top of the figure.

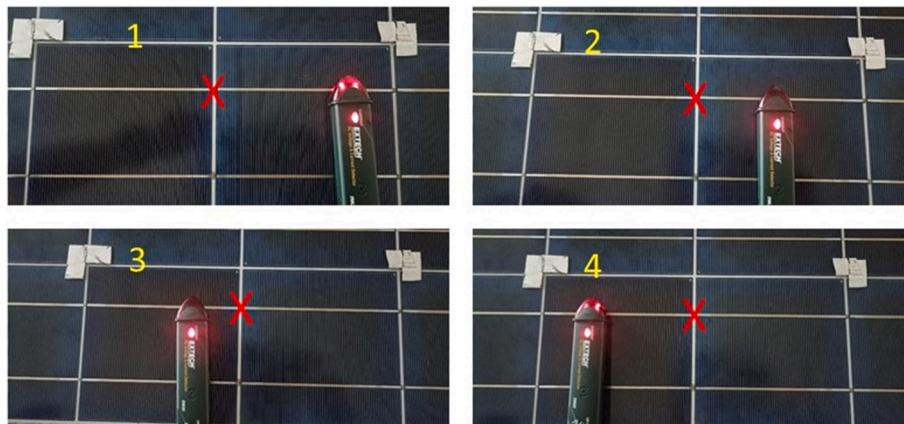
**Fig. 12** illustrates the detection of a single interruption: The detector head is moved from right to left over the ribbon bus bar. In the photo number 1, the detector LEDs are on due to the presence of current. As it moves to the left, the light dims until it disappears in photos number 2 and 3. In photo 4, the LED lights up again due to the presence of current.

**Fig. 12.** Detection of a single ribbon bus bar interruption using a current detector. The red cross is the spot where the interruption is located (as shown in Fig. 8 A). The solar module is supplied with  $I_{RMS} = 2,82$  A (3,98 A,  $I_{Max}$ ). The detector was moved from right to left. In 1 and 4 the detector LEDs light due to the presence of current. In 2 and 3 the detector LEDs off reveal the absence of current.

This procedure reveals that the interconnection marked with a red cross is interrupted. When comparing with single interruptions detected in two complete solar modules using EL the coincidence is complete.

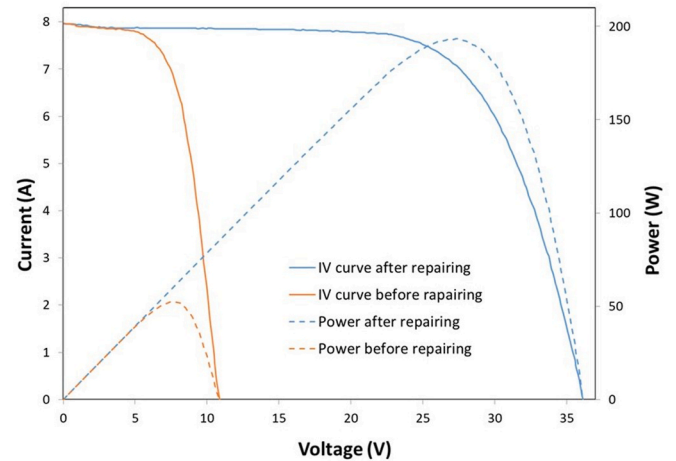
repairing process of M1 and M2 multiplies the generated power by 4. For module M3, which did not supply any power generation before the repair, 197,4 W is generated in STC after the repair. Figs. 18–20 show the IV and power-voltage curves of each PV module before and after the repair process. It is evident that the performance of all the modules has improved, especially for module M3 which had no energy generation before the repair.

Fig. 18. Module M1 IV curves and power-voltage curves before and after repairing.

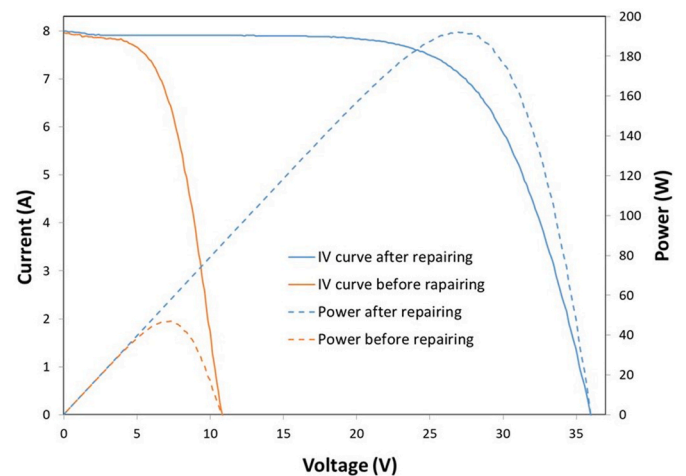
Fig. 19. Module M2 IV curves and power-voltage curves before and after repairing.

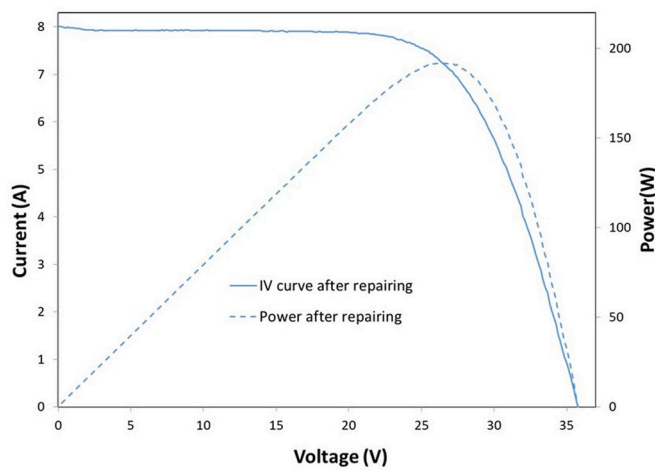
Fig. 20. Module M3 IV curves and power-voltage curves after repairing.

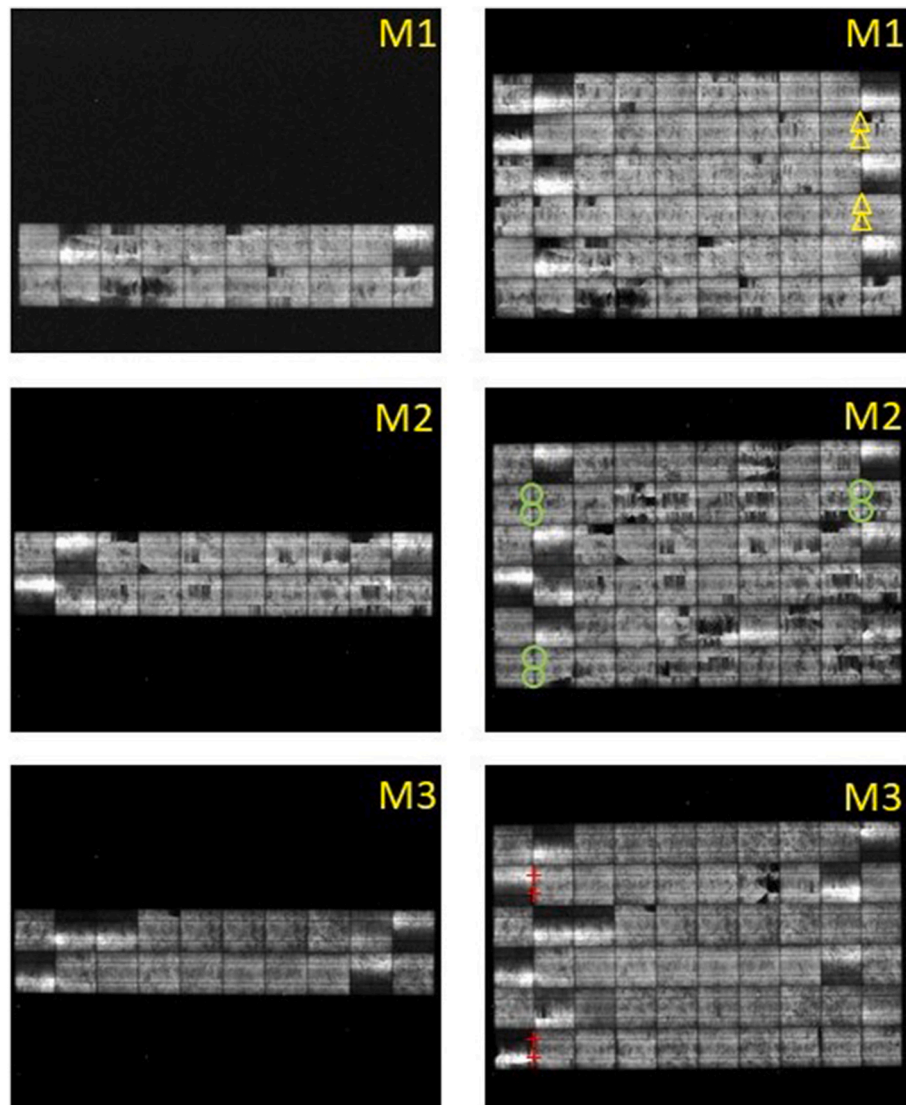
Fig. 21 shows the EL images of each module before and after the repair. EL images reveal that for modules M1 and M2 the repaired spots do not show any signal of nearby additional ribbon bus bar interruptions. However, there are other cells in both modules in which EL images show single ribbon bus bar interruptions similar to those in Figs. 8 and 12. In the case of the M3 module, single interruptions appear next to the repaired twin interruptions as well as in other parts of the module. Modules M1, M2 and M3 amount  $3 \times 120$  single cell interconnection and in Fig. 21 it can be observed a total of 24 single ribbon bus bar interruptions. That mean that after repairing twin interruptions they remain around a 7 % of single bus bar interruptions without repairing. Additionally, we have observed that in some cases, repairing a single interruption is followed by the interruption of the corresponding nearby bus bar connection, which requires further intervention to repair the newly interrupted connection. This and other issues will be analyzed in a future article focused on repairing single ribbon bus bar

Repairing single interruptions could modestly increase the power production [25]. Therefore, in order to reduce the risk of damaging the modules and due to the modest gain of power, in this work, we decided not to repair the additional single interruption revealed by the current detector (fully coincident with EL images of Fig. 21).

Fig. 21. EL images of each module before and after repairing. Modules before repairing are at left, modules after repairing at right. In the modules repaired, yellow triangles, green circles and red crosses mark the ribbon bus bars that were repaired.
