# Repairing ribbon bus bar interruptions in photovoltaic modules using non-intrusive interruption location

Ribbon bus bar interruptions in photovoltaic modules represent approximately a 10 % of photovoltaic module failures. The purpose of the present work is to repair this failures using the simplest, fastest and cheapest techniques. Twin and single intercell interruptions are defined. The first one, twin intercell interruptions, cut off electrical current flow between two cells while the second one permits current flow between cells through just one ribbon bus bar at the cost of module efficiency reduction. We propose non-intrusive methods to find precise location of single and twin intercell interruptions. A simple technique for intercell interruption repairing is described. Three modules were repaired, multiplying its power production in two cases by 4, when comparing with its non-repaired power production. The third module did not produce any electricity before repairing, and after being repaired produced a power similar to its nominal value. The proposal of repairing can be put into practice in modestly equipped factories and laboratories, without using expensive and time con

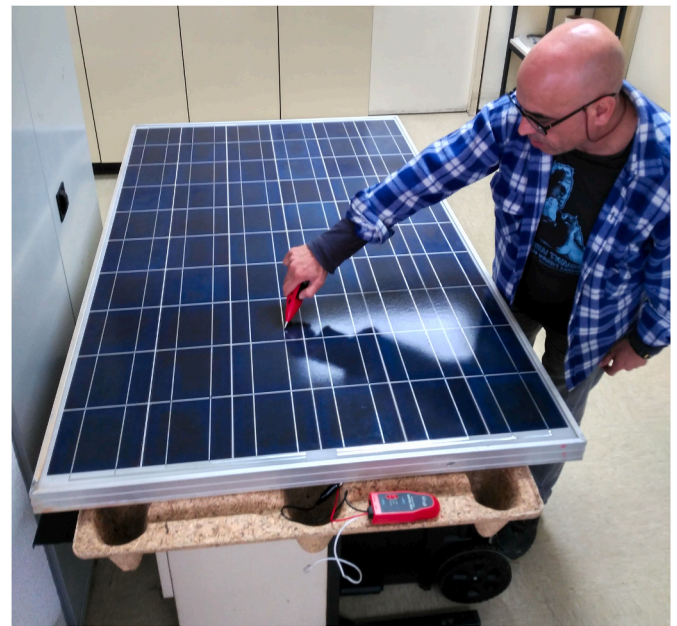
Fig. 4. Location of twin ribbon bus bar interruptions using tone tester and taking module frame as electrical earth. The module is isolated using pallet of chipboard between the work-table and the PV module. The operator displace the receiver sensor head following the ribbon bus bars, until finding a sound change which informs of a possible ribbon bus bar interruption.

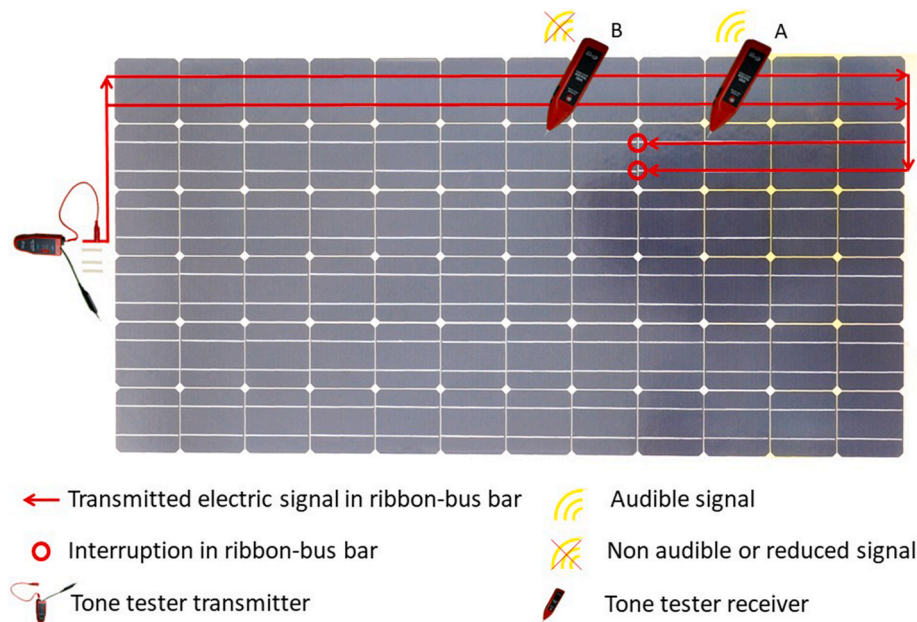
Fig. 5 illustrate the principle of operation of the device as applied to solar modules. As can be observed in the figure, electrical tester signal propagates from cell to cell except if the two ribbon bus bar (twin) interconnections are interrupted. The case where only one ribbon bus bar interrupted will be discussed later.

**Fig. 5.** Scheme of operation of a tone tester (NIMO TES011) in a PV module. On the left, tone tester transmitter is connected to module contact (red connector) and aluminum frame (black connector). At right, tone tester receiver tracks the signal in the active side of the module, by following ribbon bus bar. When the tester receiver detects the electrical signal, it emits an audible noise (A), and when the intercell ribbon bus bars (twin) are interrupted (B) the noise reduces or disappears.

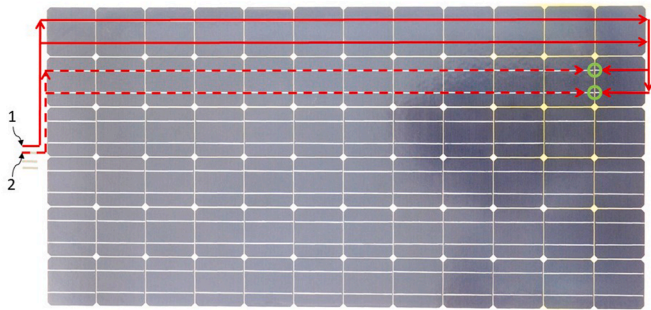
**Fig. 6.** Green circles show an intercell interruption that can be detected by connecting the tone tester transmitter to contact 1 in the module box and the transmitter sends the voltage signal through the red continuous arrow. Alternatively the tone tester transmitter can be connected to contact 2 in the module box and send the voltage signal through the discontinuous arrow.

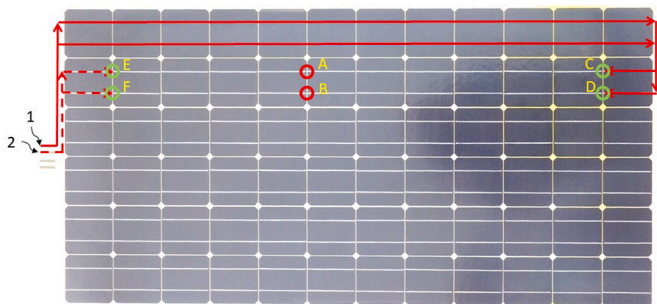
**Fig. 7.** Map of interruption A, B, C and D in a hypothetical module. Red lines represent tone tester electrical signal propagation and numbers 1 and 2 represent contacts in the connection box.

possible to find a hypothetical case of interruption between interconnections CD and EF. Referring to Fig. 7, both interruptions can be easily located, using contact 1 for CD and contact 2 for EF but they

would make the AB interruption undetectable regardless of the terminal checked. The procedure to follow is to repair the new interruption found, and so on, if necessary.

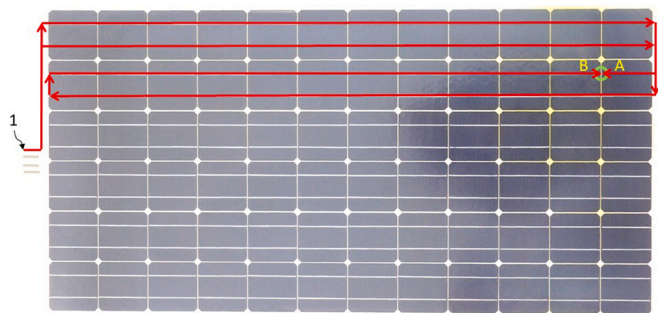
While tone tester technique would be a desired method for single ribbon bus bar interconnection failures, it is not valid for this purpose. Fig. 9 shows an example of how the interruption would be hidden. In the image, the green circle represents a single bus bar interruption and the red arrow the electrical voltage signal generated by the tone tester transmitter. This electrical signal reaches the interruption on sides A and B. As both borders of the bus bar interruption are very close, the tone tester receiver detects a signal from both sides of the fracture, A and B. Therefore, the tester receiver is unable to distinguish the breakdown, hiding the interruption.

**Fig. 9.** Green circle represents a single interruption, situated between references A and B. Red arrow shows how the electrical voltage (not current) signal generated by the tone tester transmitter at contact 1 that can reach the interruption on both sides.

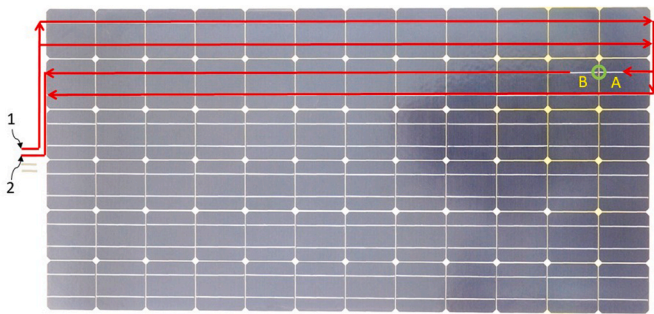
**Fig. 11.** Green circle represent a single interruption, situated between references A and B. Red arrow shows how an electrical current signal applied to the solar module contacts 1 and 2 can reach the interruption on both sides, but showing a decay of current at zones A and B around single interruption.

power supply. The red arrow shows how an electrical current signal applied to contacts 1 and 2 of the solar module can reach the interruption on both sides, but shows a current decay at zones A and B around the single interruption. This interval before and after the single interruption could be detected with a current detector.

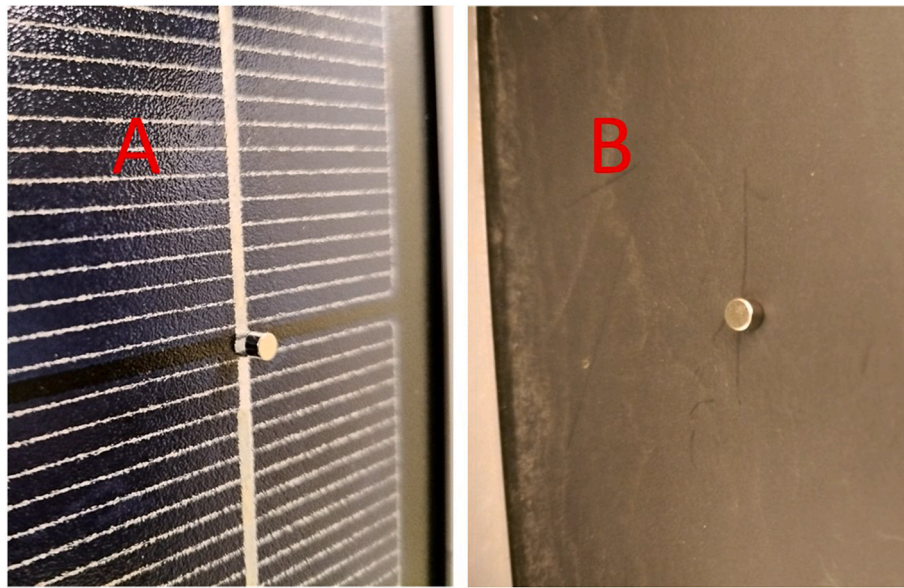
**Fig. 15.** Location of the point to be drilled in the backsheet of a non-translucent module, using two 2 mm Ø cylindrical neodymium magnets: A) neodymium magnet in the front of the module and B) neodymium magnet on the backsheet, magnetically coupled to magnet A).

backsheets. In this working area, the drilling will be carried out that will allow access to the ribbon bus bar interruptions. A strong light, incident from the front side, helps in this task as can be seen in steps 1 and 2 of Fig. 14: In the case of a translucent backsheet, it is possible to see the work area by illuminating the front of the solar module, detecting the bus in its back and marking the area to be intervened with a pen. In cases where the backsheet is dark or not translucent, the location of the point to be drilled in the backsheet is done using 2 mm Ø cylindrical neodymium magnets, one on the front of the module and the second on the backsheet. Placing the first magnet on the module glass above the interruption (Fig. 15A) allows the second magnet to be placed on the backsheet (Fig. 15B) in the same interruption area, locating the work area and marking the area to be drilled with a pen.

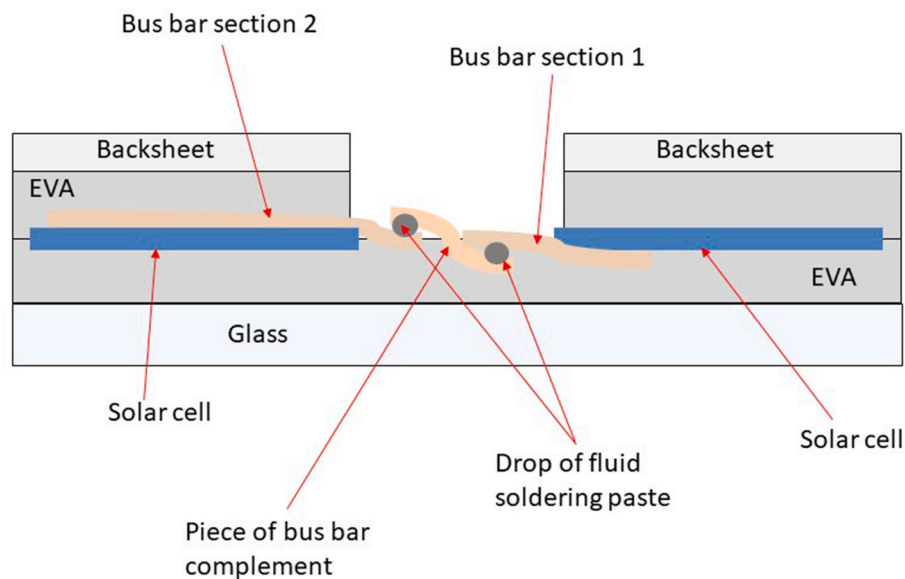
**Fig. 16.** Scheme of the layout of the two cells, the interrupted bus bar, the additional piece of bus bar and drops of fluid soldering.

The most delicate step appears in Fig. 14.6: Bus bar must be separated into two parts at the point of the interruption, so that a complementary piece of bus bar can be inserted (Fig. 16). Fig. 15 presents a scheme of the layout of cells, bus bars sections 1 (close to the module glass) and 2 (close to the module backsheet), the additional piece of bus bar and drops of fluid soldering. First, the bus bar section 2 is lifted and then the bus bar section 1 in Fig. 16 is lifted. For this task, a cutter and a little screwdriver are used (Fig. 14.6). The screwdriver is used to force the bus bar to fold at the selected place, taking care of not to damage the cell. The cutter is used to properly fold the bus bar. The bend helps to apply flux to the bus bar, in order to facilitate the soldering process (Fig. 14.7). A tiny drop of fluid soldering paste is applied to the extreme of the bus bar complement which is typically around 5 mm long (see Fig. 14.8). This is then inserted under the original bus bar section 1 (see Fig. 14.9 and Fig. 16) on the active face of the solar cell (Fig. 16). Thereafter the original bus bar and the complement piece of bus bar are soldered (Fig. 14.10) and the surplus bus bar is cut off (Fig. 14.11). The temperature of the soldering iron tip will be around 183 °C, which is the nominal fusion value for the soldering paste used.

Finally, the new piece of bus bar receives another drop of fluid soldering paste (Fig. 14.12 and Fig. 16), and is soldered to the original bus bar section 2 (Fig. 14.13 and 16) which is welded to the back of the cell. A continuity check using a multimeter (Fig. 14.14) or tone tester is essential before filling the hole with silicone (Fig. 14.15).
